CASE STUDY

Structural Refurbishment

BT Pendleton

Office

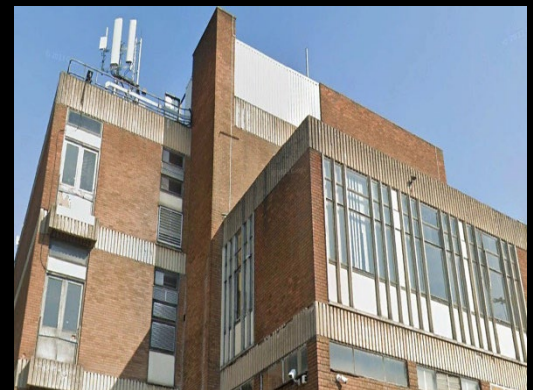
Before

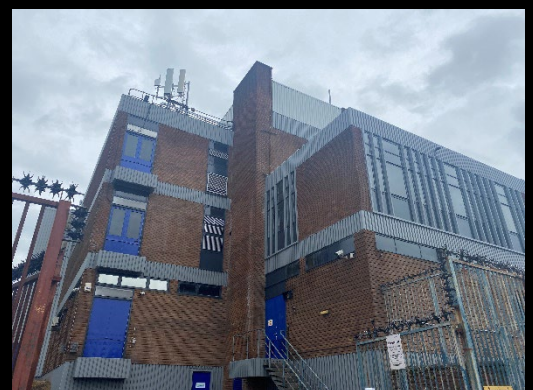
After

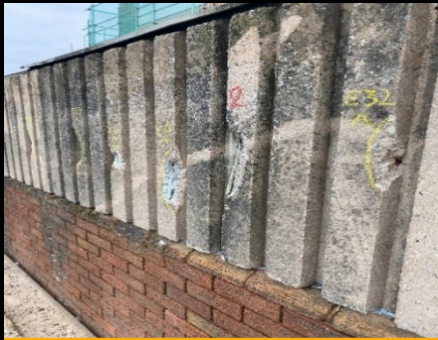
Marking up the extent of repair

All areas were thoroughly cleaned using a high-pressure water jetter to remove dirt, debris and loose or deteriorated concrete before a full hammer survey was carried out to highlight the extent of the repairs, once this was completed, we were then able to start the repair process.

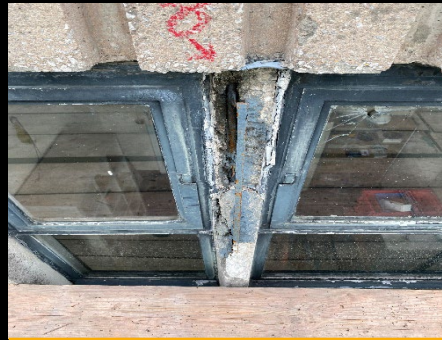
The standard of repair

All perimeters of the repairs were saw cut to sound concrete using hand held grinders and the deteriorated concrete removed using electric breakers back to sound concrete, any exposed rebar was then cleaned using wire brushes before a protective coating was applied. A suitable repair mortar was then applied by hand according to the manufacturer's instructions and consideration was taken regarding the weather conditions to protect the repairs from extreme temperatures, moisture or drying winds during the curing process, properly executed concrete repairs can extend the life span of the structure and restore its functionality and aesthetics.

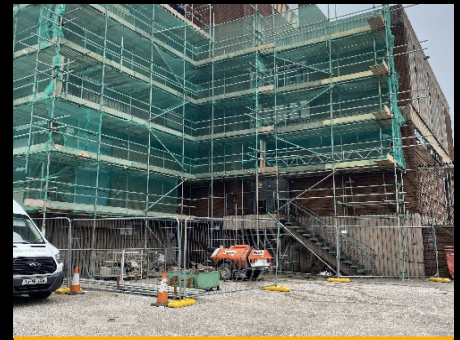
Scaffold being erected

Due to the unique design of the building a full scaffold was required to provide access to all external faces to allow multiple trades to carry out their works.

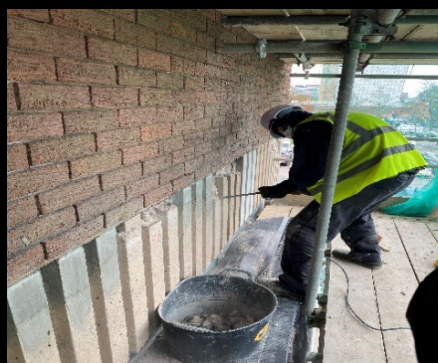
Removal of concrete

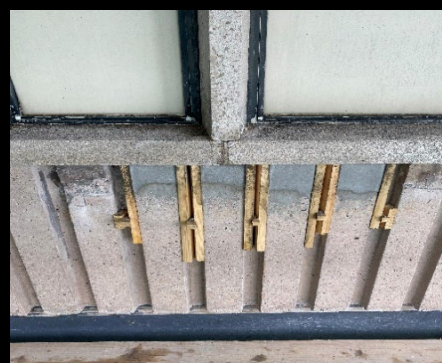
Reinstatement

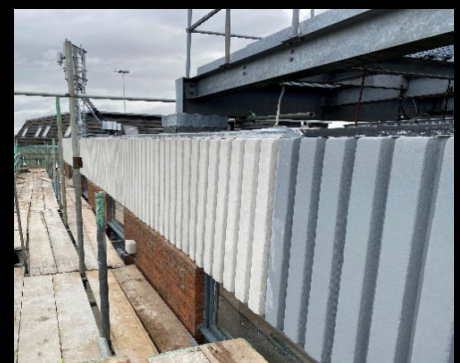
Protective coatings applied

Once all concrete repairs were complete an application of corrosion inhibitor was applied to protect the reinforced steel within the concrete structure from further corrosion caused by environmental damage and carbonation. This was applied in multiple coats using sprayers to ensure even coverage over the entire concrete surface. Adequate time was allowed for the inhibitor to migrate into the concrete before a final wash over the surface to wash off any excess material.

A fairing coat was then applied to the concrete surfaces to provide a smooth, uniform, and visually appealing finish before 2 coats of anti-carbonation paint was applied to protect the concrete surfaces from carbonation, which can lead to the corrosion of reinforcement bars this also improved the appearance of the building giving it a uniform visually appealing finish.

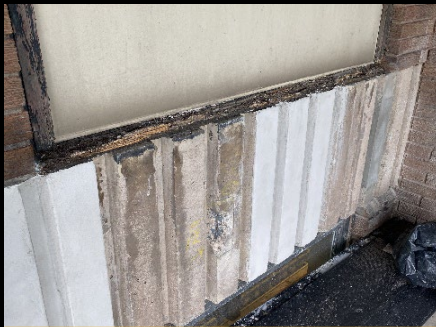
Concrete repairs

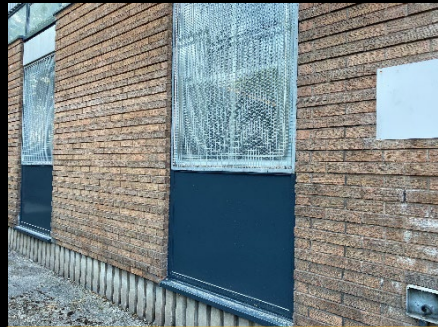
New window panels installed

The asbestos within the refurbishment report highlighted the requirement of the removal of the window panels and replacement with A2 versapanel boards, this upgrade not only ensures a safer environment by eliminating hazardous materials but also enhances the overall quality and durability of the window installations. There was also asbestos within the mastic around all window frames which required removing and replacing, all works involving asbestos were executed with the highest standards of safety and efficiency by a licenced specialist. This comprehensive approach minimizes risks and protects both individuals and the environment from asbestos-related hazards, the windows throughout the building were coated in BT's corporate colours which are integral to its brand identity.

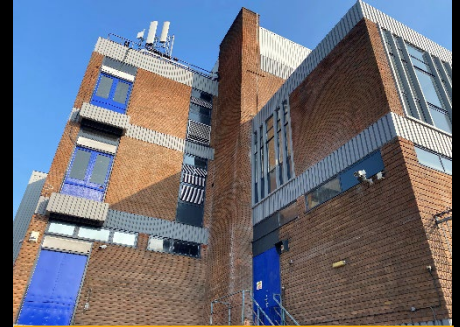
Elevations completed

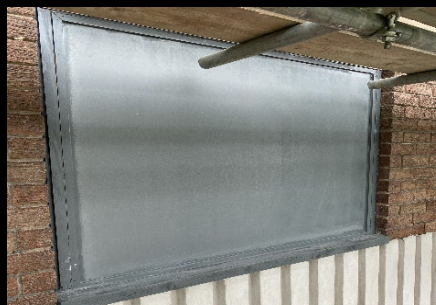
Primer coat applied to panels

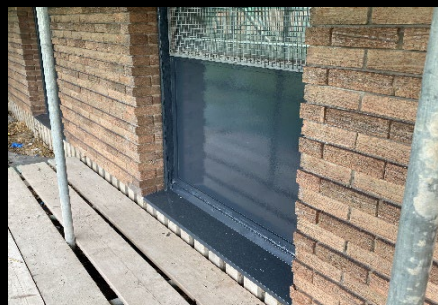
Final coat applied to panels

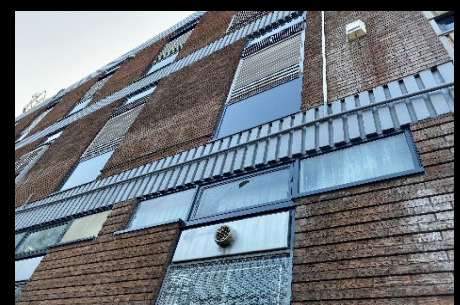
Elevation now complete

This once run down building now stands transformed, showcasing a fresh and modern appearance following Makers extensive refurbishment works which ensures the building meets current standards ultimately prolonging usability, lifespan and preserving its value.
